NATIONAL PROGRAM FOR INSPECTION OF NON-FEDERAL DAMS
LAKE KANASATKA DAM (N. (U) CORPS OF ENGINEERS WALTHAM
MA NEW ENGLAND DIV MAR 80

REPORT DOCUMENTATION PAGE		READ INSTRUCTIONS BEFORE COMPLETING FORM
1. REPORT NUMBER NH 00125	2. GOVT ACCESSION NO.	3. RECIPIENT'S CATALOG NUMBER
4. TITLE (and Subtitle) Lake Kanastka Dam NATIONAL PROGRAM FOR INSPECTION OF NON-FEDERAL DAMS		5. TYPE OF REPORT & PERIOD COVERED INSPECTION REPORT

Lake Kanasatka Dam
Moultonboro, NH

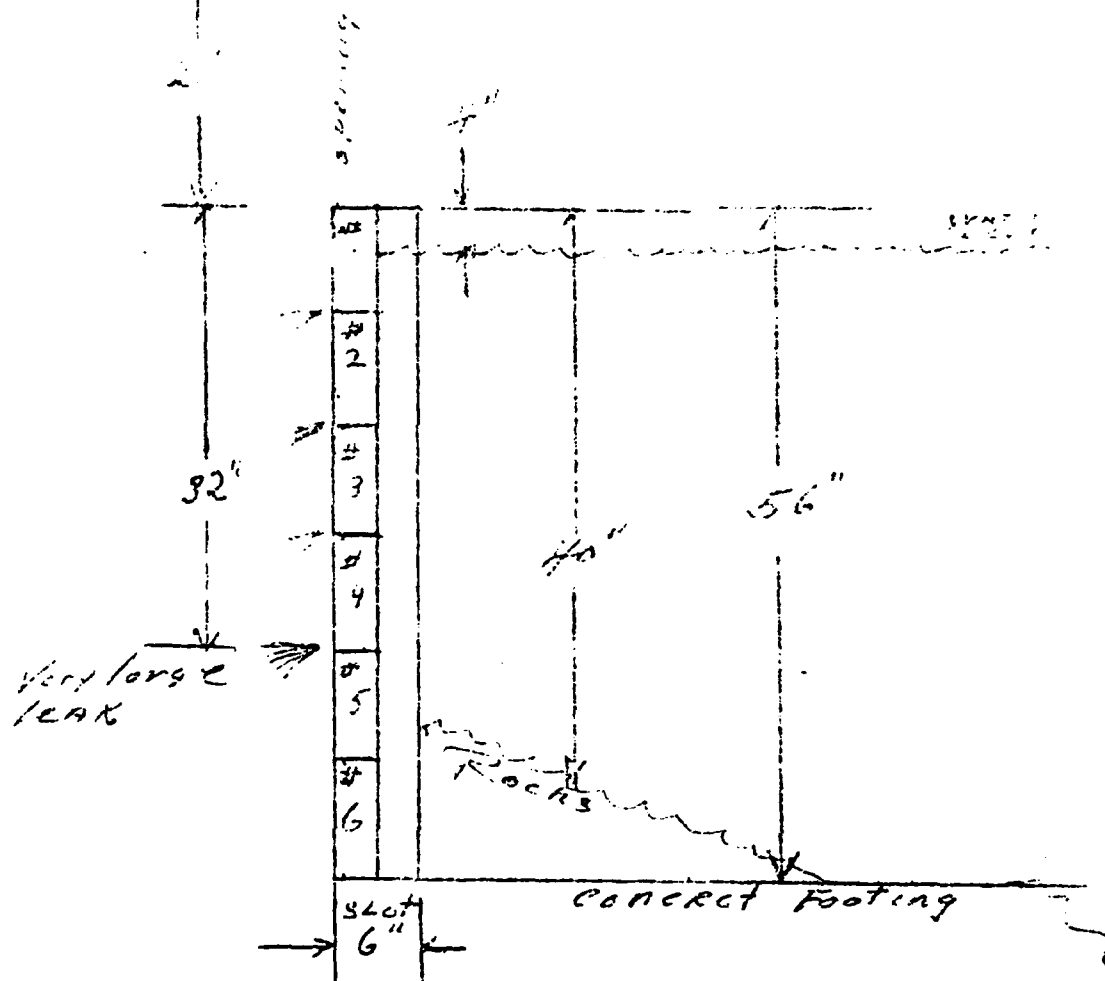
FIGURE # 2 : END VIEW - DAM AT ROUTE # 25 - LAKE KANASATKA

1. ROCKS HAVE BEEN STACKED AT APPROX BOARD 5 LEVEL
2. LEAKS AT ALL BOARD SEAMS - VERY LARGE LEAK AT BOARD 4 & 5 - A SHOE IS STUCK IN BOARD

SECURE BOARDS . STOP LEAKS. RAISE BOARD LEVEL AT LEAST 12 TO 14 INCHES.

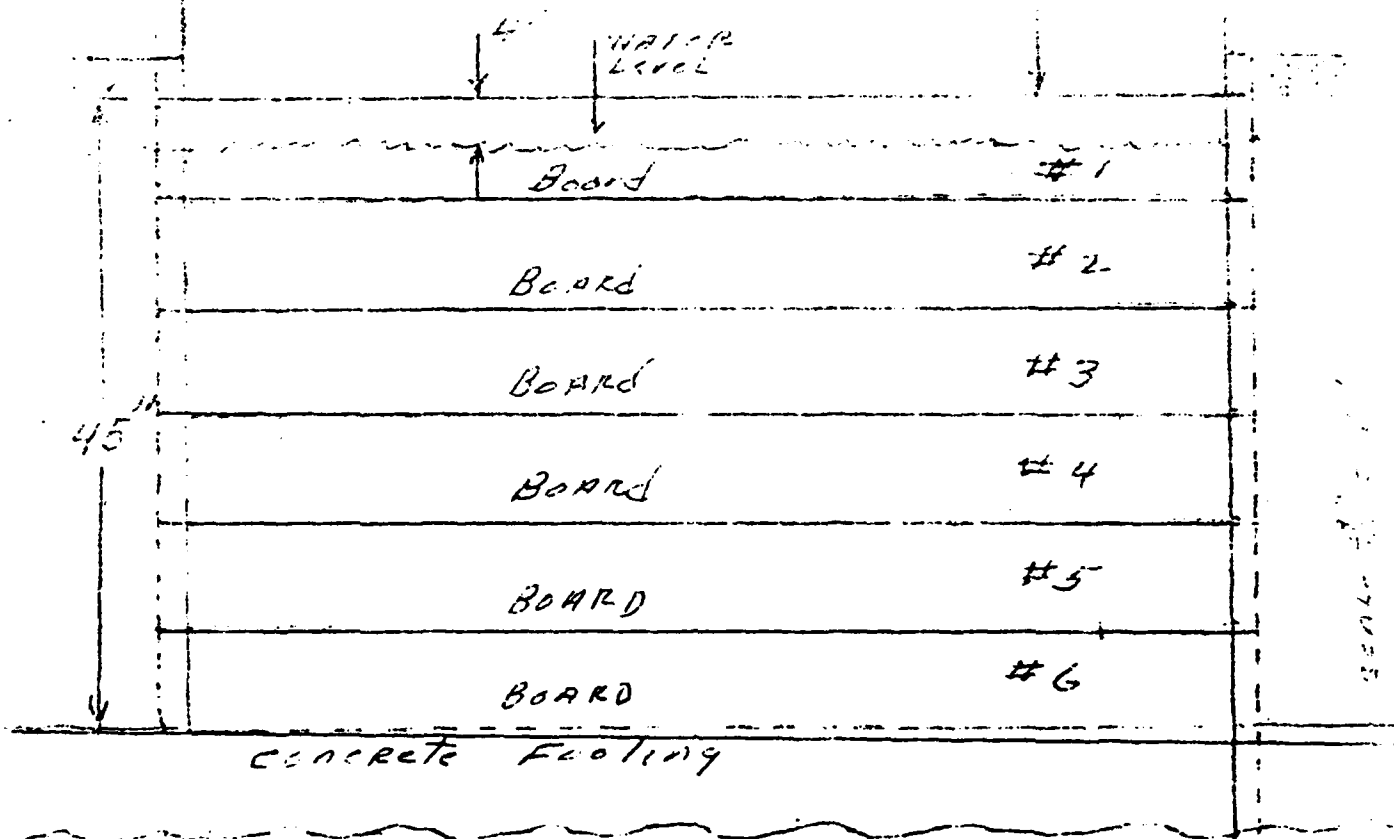
FIGURE # 1 : LAKE SIDE VIEW - DAM AT ROUTE # 25 - LAKE KANASATKA.

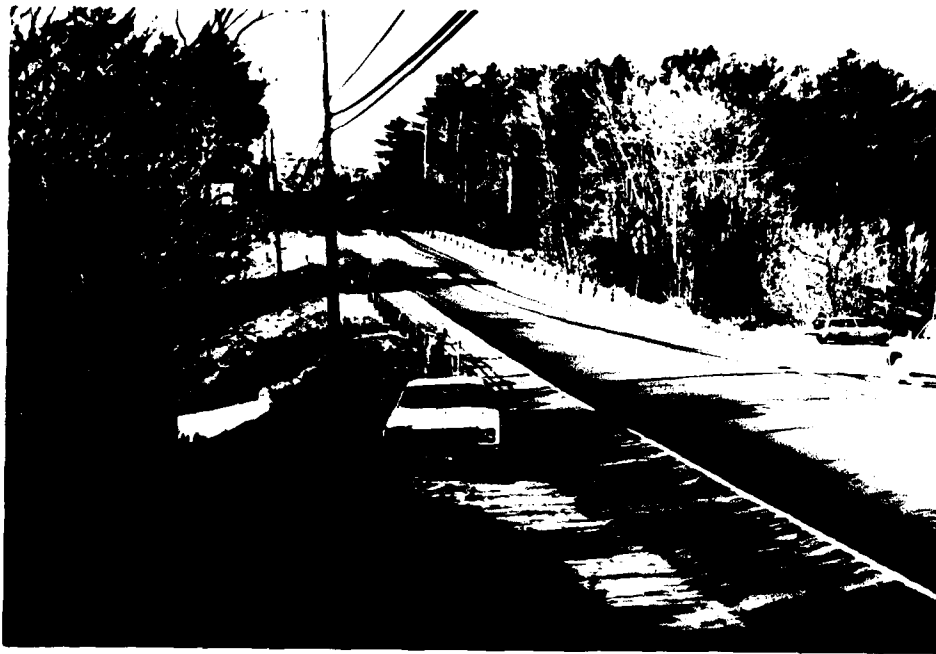
The horizontal alignment of the crest is straight. The crest elevation varies along the vertical curve for the highway, Photo No. 6. The roadway pavement covering the crest of the dam is in generally good condition. There are several transverse cracks in the pavement, the largest of which is about 1/8 in. in width.

6. Downstream side and alignment of roadway from left end of dam
